# BELZONA PREVENTS COSTLY LEAKAGE

Industry: *General Industry*  
Application: *GSS-Gaskets, Seals and Shims*  
Substrate: *Carbon Steel*  
Products: *Belzona® 1812 (Ceramic Carbide FP)*

Customer Location: *Cement plant, Bulgaria*  
Application Date: *March, 2008*

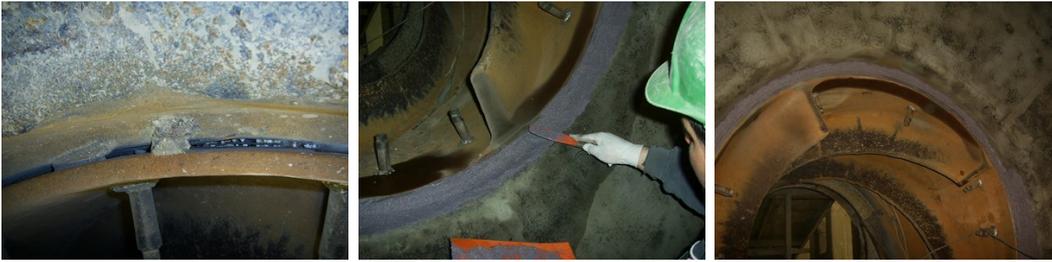
## Photograph Descriptions

*The ingress of limestone particles into the 10-20mm gap between the tubular screw conveyor and its housing leads to wear and leakage of milling media outside the mill.*

\* View of the gap between the tabular screw conveyor and the housing , \* Belzona® 1812 being applied , \* Completed application

Application was carried out in accordance with modified versions of Belzona Know How Leaflet GSS-9 and VPF-2.

The Belzona was chosen in order to prolong the life of tubular screw conveyor. The customer had used different epoxy-based products to solve the problem but with limited success. Welding was not considered due to high cost and stress buildup. The Belzona solution proved to be much easier and faster to apply saving the plant more than 5000 euros in replacement and maintenance costs.
