Corroded Bulkhead Reinforced with Belzona

ID: 10245

Industry: Military
Application: SOS-Ships and Offshore Structures

Customer Location: Devonport, New Zealand
Application Date: April 2026

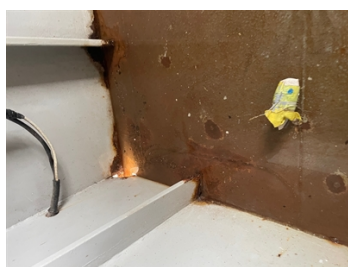
Continually wet conditions surrounding the mainmast made conventional solutions impractical

Localised corrosion evident in several locations at the base of the bulkhead

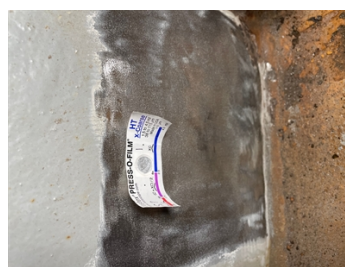
Each location was prepared with a flap disc and MBX to an average of 60 microns in line with SSPC-SP11.

Surface preparation was carried out with pneumatic tools to SSPC-SP11, ensuring that an acceptable profile and standard of cleanliness was achieved. Steel plates were measured and cut to fit the application areas and profiled with the MBX on site. Belzona 1161 (selected due to the heavy rain and constant ingress of water into the area) was mixed and applied to the doubler plates and the bulkhead. The plates were then pressed into place and extruded material removed.

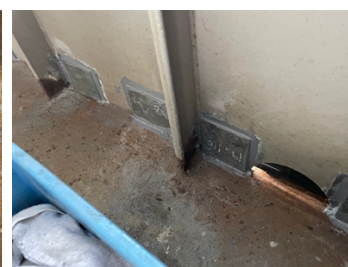
Steel doubler plates bonded in place and ready for painting
