Pipeline leakage arrest and reinforcement using Belzona composite systems

ID: 10247

Industry: Power
Application: VPF-Valves, Pipes and Fittings
Substrate: Carbon steel
Products: Belzona 1161 (Super UW-Metal), Belzona 5841

Customer Location: India
Application Date: December 2025

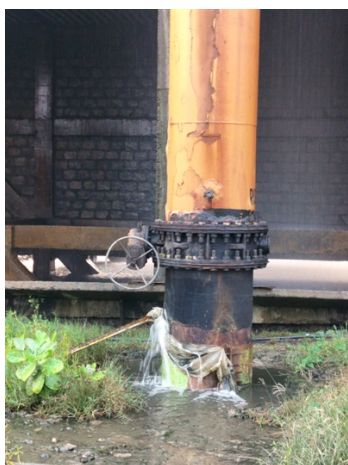
From ground level to a height of approximately 1.5 m, the riser pipe had deteriorated due to the presence of algae and bacteria below ground level. The section in question had previously been wrapped with bitumen in an attempt to provide protection.

Surface was prepared with copper slag grit blasting.

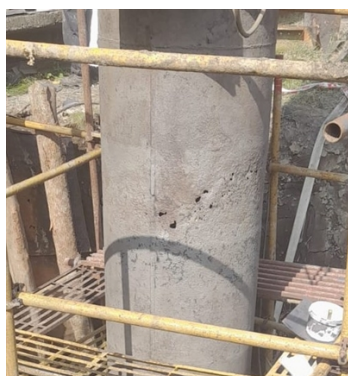
Belzona 1161 (Super UW-Metal) applied to rebuild damaged portion followed by plate bonding

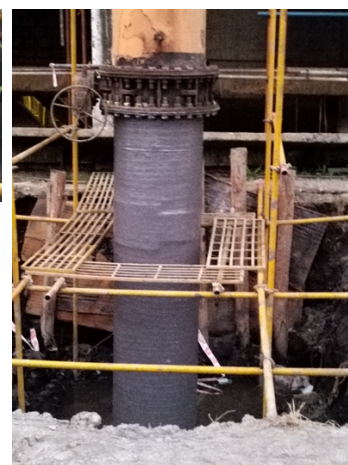
Finally, the affected areas were reinforced with Belzona 5841 and Belzona 9371 composite repair system
