BELZONA REPAIRS CASING OF CEMENT BALL MILL

Application: *SHM-Solids Handling Machinery*

Customer Location: *Cement plant, Bulgaria*

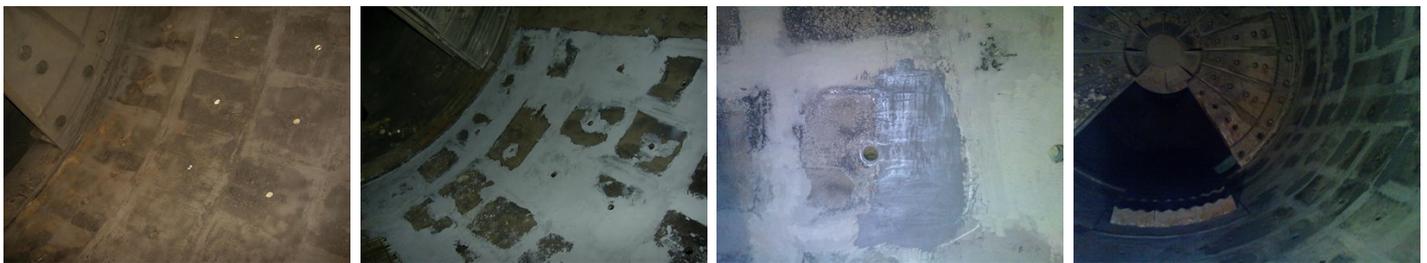
Photograph Descriptions

Wear on the shell when operating with missing protective tiles.

- * View of the damage to the shell after dismantling the tiles ,
- * Application of Belzona® 4111 after blasting of the surface ,
- * Smoothing of the area with Belzona® 1121 ,
- * Application of Belzona completed and the bolting of the new wear plates over the repair has started ,

Application was carried out in accordance with the modified version of the Belzona Know-How System Leaflet SHM-7.

Both Belzona products were used to restore the profile of the shell in order to fulfill the strict requirements of the tile manufacturer before the installation of new tiles.
