BELZONA REPAIRS CASING OF CEMENT BALL MILL

Application: SHM-Solids Handling Machinery

Customer Location: Cement plant, Bulgaria

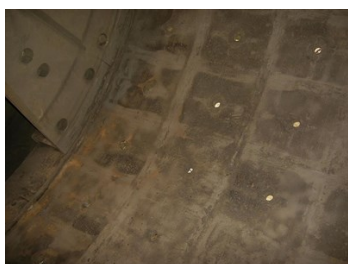
Wear on the shell when operating with missing protective tiles.

- * View of the damage to the shell after dismantling the tiles ,
- * Application of Belzona® 4111 after blasting of the surface ,
- * Smoothing of the area with Belzona® 1121 ,
- * Application of Belzona completed and the bolting of the new wear plates over the repair has started ,

Both Belzona products were used to restore the profile of the shell in order to fulfill the strict requirements of the tile manufacturer before the installation of new tiles.
