Belzona Solution for Seawater Butterfly Valves

ID: 10250

Industry: Oil & Gas
Application: VPF-Valves, Pipes and Fittings
Substrate: Carbon steel
Products: Belzona 1311 (Ceramic R-Metal), Belzona 1321 (Ceramic S-Metal)

Customer Location: ABU DHABI, UNITED ARAB EMIRATES
Application Date: January 2026

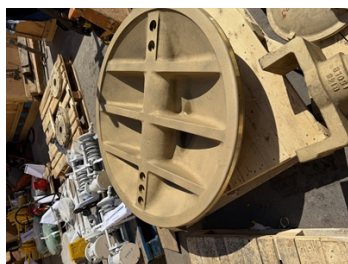
Critical erosion-corrosion damage in butterfly valves.
