# Can filler support frame protected with Belzona 4341

ID: 10252

Industry: Food & Drink  
Application: TCC-Tanks and Chemical Containment Areas  
Substrate: Other  
Products: Belzona 4341 (Magma CR4)

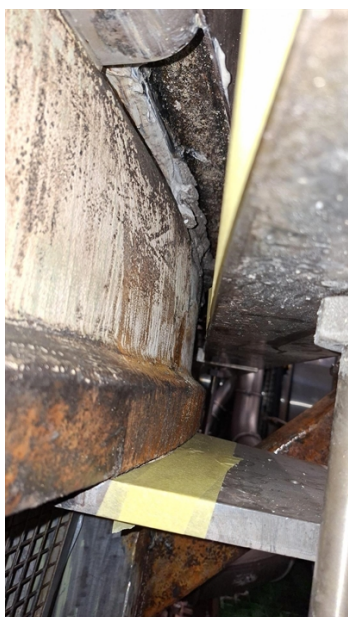
Previous coatings had proven inefficient and underlying steelwork was insufficiently protected

Over time, the support structure has been coated with various paint systems. Unfortunately, these have not performed as intended and were breaking down at an accelerated rate, leaving the underlying steelwork insufficiently protected.

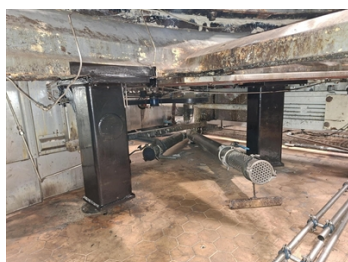
Customer has a filler line that is regularly subjected to chemical cleaning processes. The upper section of the line is constructed from stainless steel and operates to a high standard. However, the support frame is manufactured from cast material and was installed prior to the stainless steel upgrade and is now exhibiting signs of corrosion due to repeated chemical attack.

Support structures required a long term solution against chemical attack

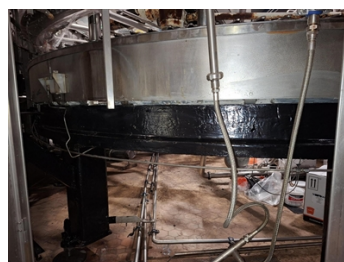
Belzona 4341 was applied as a long-term solution for protection against chemical attack

remove contaminants, followed by surface preparation to achieve an appropriate surface profile for coating adhesion. Belzona® 4341 was applied in two coats at a target thickness of 400 microns per coat, forming a continuous, chemically resistant barrier designed to protect against acidic attack and environmental exposure.

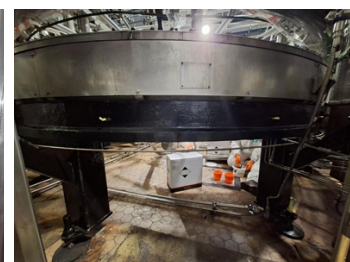
Completed application of Belzona 4341 enhances durability and extends operational life of support structure
