Belzona Solution for Deep Corrosion Pitting Repair on FWD Main Deck Area for Vessel

ID: 10254

Industry: Marine
Application: SOS-Ships and Offshore Structures

Substrate: Aluminum
Products: Belzona 1111 (Super Metal), Belzona 1321 (Ceramic S-Metal)

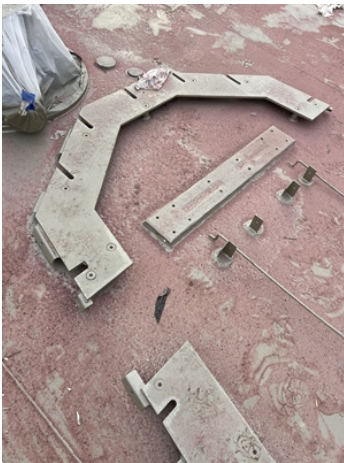
Surface preparation on the vessel deck in progress

1. Surface preparation was carried out using power tools to achieve an SSPC-SP 11 (Power Tool Cleaning to Bare Metal) standard, ensuring complete removal of corrosion and creation of a suitable surface profile.
2. All residues were thoroughly cleaned prior to application.
3. Belzona 1111 (Super Metal) was applied to rebuild the pitted deck areas, restore the original profile, and blend smoothly with the

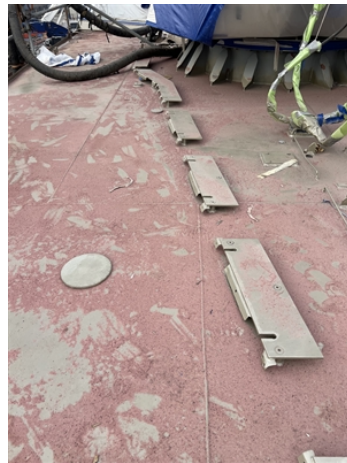
Surface preparation work underway on the vessel deck

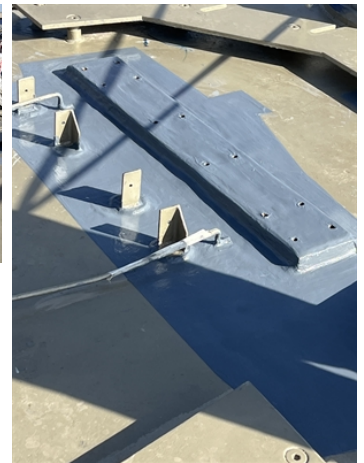
Close-up view of Belzona 1111 (Super Metal) being applied to repair pitting, followed by Belzona 1321 (Ceramic S-Metal) coating on the vessel deck

4. For additional long-term protection, Belzona 1321 (Ceramic S-Metal) was applied as a topcoat to enhance resistance against corrosion, abrasion, and harsh marine exposure.
