Belzona Repairs a Corroded Flange at a Gas Yard

ID: 10255

Industry: Oil & Gas
Application: VPF-Valves, Pipes and Fittings
Substrate: Carbon steel
Products: Belzona 1111 (Super Metal)

Customer Location: Auckland
Application Date: April 2026

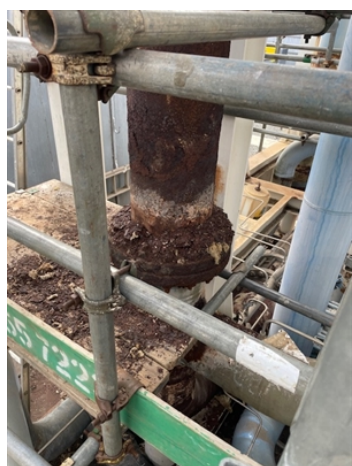
During routine maintenance, a section of pipe (originally under insulation) was found to be severely corroded, with the flange particularly affected. The client determined that the best course of action was to seal the pitting and the flange boundary using Belzona as a temporary measure until the next shutdown.

The flange was severely corroded, requiring the bolts to be cut out for disassembly.

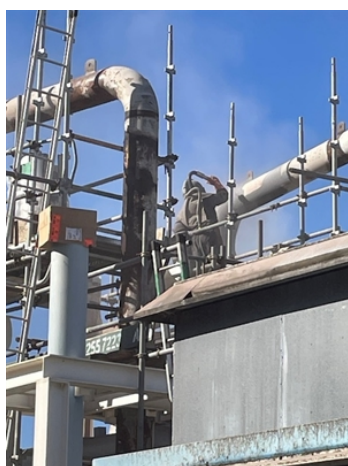
Grit blasting of the pipework was carried out and took most of the morning.

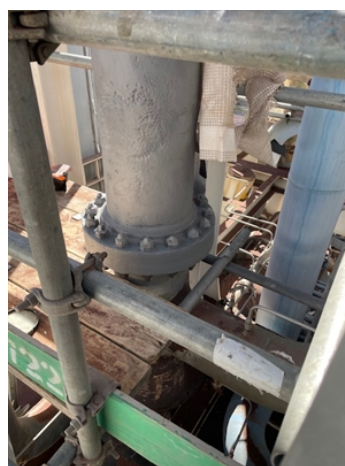
Once blasted, the flange was found to be in satisfactory condition, and the client decided to carry out a temporary repair using Belzona 1111 (Super Metal) until the next major maintenance shutdown.

After blast cleaning, the asset is inspected and the metal thickness is assessed. Belzona 1111 (Super Metal) is then used to restore the original geometry of the flange and seal the boundary. This ensures that the asset can be repainted and returned to service

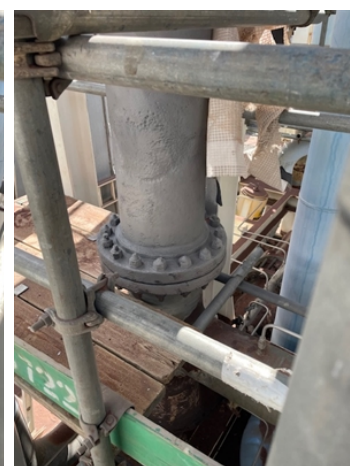
Condition of the flange boundary after sealing with Belzona 1111 (Super Metal).
