# Mud Pump Casing Repair and Protective Coating Application

ID: 10263

Industry: Oil & Gas  
Application: CEP-Centrifugal Pumps  
Substrate: Cast Iron  
Products: Belzona 1311 (Ceramic R-Metal), Belzona 1321 (Ceramic S-Metal)

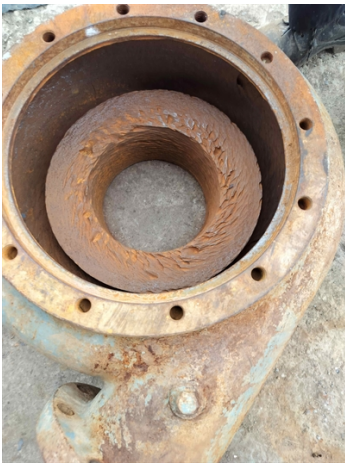
Severe erosive wear of the pump casing due to the presence of grit and rock particles in the mud and oil extracted from underground formations.

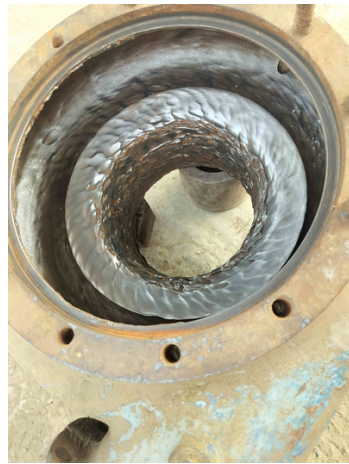
Surface preparation carried out using hand-held tools.

1. Surface preparation was carried out using hand-held tools (Bristle Blaster and grinder).
2. The surface was then cleaned with a suitable cleaner/degreaser to remove all loose particles. A minimum surface profile of 75 microns and surface cleanliness to ISO 8501-1 Sa 2.5 standard was achieved.
3. Belzona 1311 (Ceramic R-Metal) was applied to the damaged areas to rebuild metal loss in the casing.
4. Belzona 1321 (Ceramic S-Metal) was applied in two coats to provide a protective barrier in accordance with the Instructions for Use (IFU).

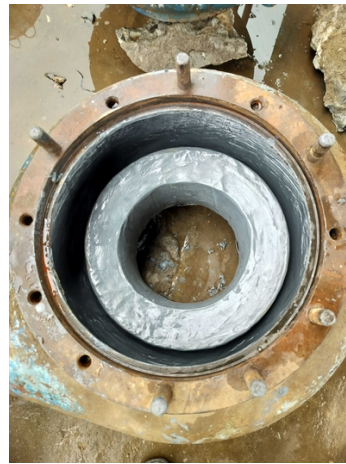
The damaged portion was rebuilt using Belzona 1311 (Ceramic R-Metal).

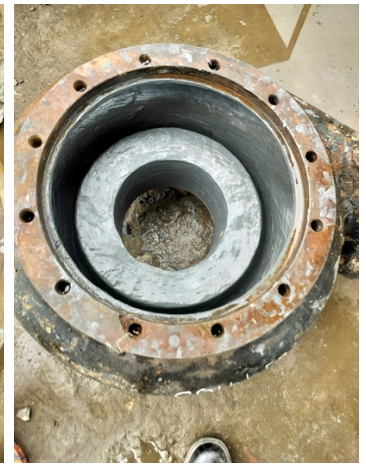
The application was completed using Belzona 1321 (Ceramic S-Metal).
