Leaking Industrial Wash-Water Pipe at a Steel Mill Repaired with Belzona

ID: 10268

Industry: Steel & Metal Processing
Application: VPF-Valves, Pipes and Fittings
Substrate: Carbon steel
Products: Belzona 7311

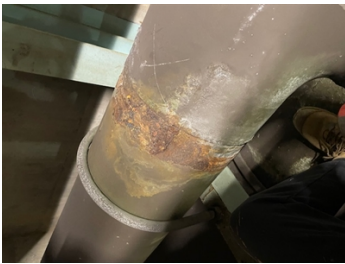
The heavily corroded areas indicated potential thin-wall issues, and the client was reluctant to carry out welding.

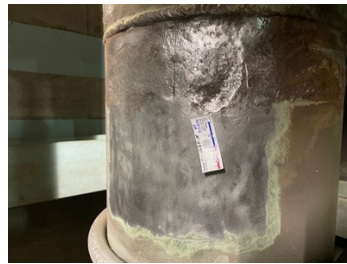
Surface preparation was carried out using grinders and Bristle Blaster tools in accordance with the specification (SSPC-SP 11).

Emergency leak sealing clamps were removed, and surface preparation was carried out around the defect areas using grinders and Bristle Blaster tools, as abrasive blasting was not practical in those locations. Once the areas around the defects had been cleaned and prepared, the rolled steel plates were prepared in the same manner, and Belzona 7311 was applied to both surfaces.

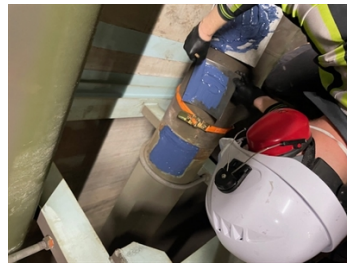
Belzona 7311 was applied to the pipe and to a rolled steel plate, which had also been surface prepared using the Bristle Blaster.

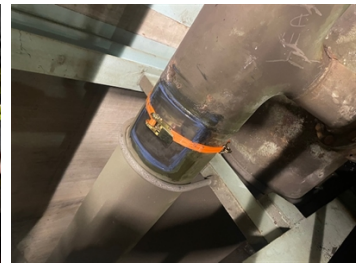
The plates were secured in place using ratchet straps during curing to ensure they did not shift.

The plates were then pressed onto the repair areas and secured using ratchet straps. To complete the repair, excess Belzona material extruded around the plate edges was removed to form a clean chamfer finish.
