BELZONA RESEATS NEW RUDDER BEARING BUSH

Application: SOS-Ships and Offshore Structures

Customer Location: Dockyard, Bulgaria

Ships rudder bearing

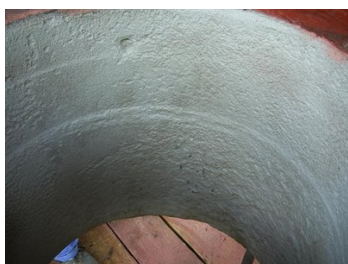
Severe corrosion and impact wear of the bush housing resulted in annular gap between the housing and the bearing bush in excess of 8 mm.

* Severe corrosion on the housing clearly evident after blasting , * New bearing bush with drilled injection ports and jacking bolts for alignment , * Sealing the bottom of the bush with Belzona® 1221 , * Injection of Belzona® 1321 completed ,

The injection of Belzona® 1321 was done through injection ports drilled in the bearing wall.
