# BELZONA RESEATS NEW RUDDER BEARING BUSH

Industry: *Marine*  
Application: *SOS-Ships and Offshore Structures*

Ships rudder bearing

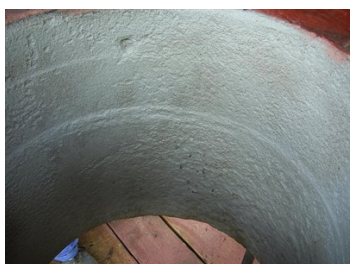
*Severe corrosion and impact wear of the bush housing resulted in annular gap between the housing and the bearing bush in excess of 8 mm.*

\* Severe corrosion on the housing clearly evident after blasting , \* New bearing bush with drilled injection ports and jacking bolts for alignment , \* Sealing the bottom of the bush with Belzona® 1221 , \* Injection of Belzona® 1321 completed ,
