BELZONA RESEATS NEW RUDDER BEARING BUSH

ID: 1027

Customer Location: *Dockyard, Bulgaria*
Application Date: *January, 2008*

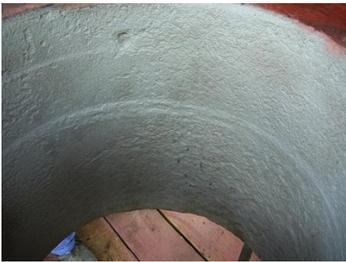
Severe corrosion and impact wear of the bush housing resulted in annular gap between the housing and the bearing bush in excess of 8 mm.

* Severe corrosion on the housing clearly evident after blasting , * New bearing bush with drilled injection ports and jacking bolts for alignment , * Sealing the bottom of the bush with Belzona® 1221 , * Injection of Belzona® 1321 completed ,

Application was carried out in accordance with Belzona Know-How System Leaflet SOS-9.
The injection of Belzona® 1321 was done through injection ports drilled in the bearing wall.
