# Glass fused lined steel tank repairs with Belzona going strong after 10 years of service

Industry:	Water / Wastewater	Customer Location:	Yorkshire
Application:	TCC-Tanks and Chemical Containment Areas	Application Date:	April 2016
Substrate:	Other		
Products:	Belzona 1111 (Super Metal), Belzona 1981 (SuperWrap II), Belzona 5831 (ST-Barrier)

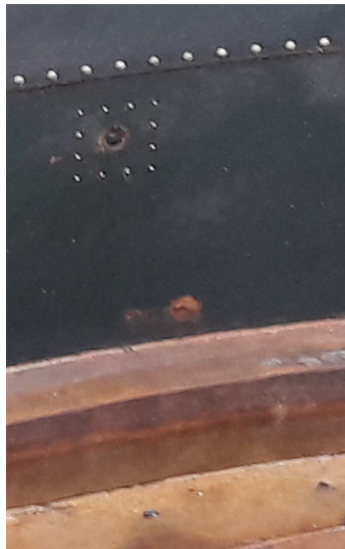
Glass-fused lined steel tanks are widely used due to their excellent chemical resistance; however, damage to the substrate can present significant operational challenges. In this instance, the tank had developed extensive through-wall defects caused by external corrosion in the lower sections of the structure, combined with H<sub>2</sub>S (hydrogen sulphide) attack within the upper internal gas phase areas.

Example of defect from inside the tank

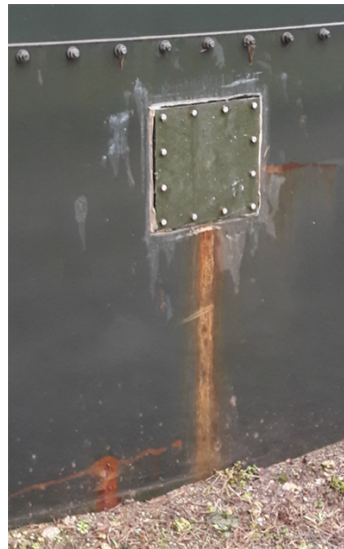
Example of defects from the external

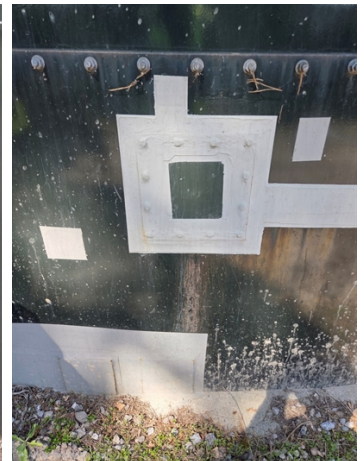
Repairs still in great shape 10 years on.

The success of this project led to wider adoption of the repair methodology by the water authority, with Belzona subsequently completing thousands of similar repairs across comparable tank assets. Notably, this original application was one of the first of its kind and remains in excellent condition more than 10 years after installation, demonstrating the long-term reliability and effectiveness of the solution.

In addition to identifying suitable bonding and coating materials, the decision was made to utilise pre-formed Belzona SuperWrap II plates instead of traditional steel reinforcement plates. This approach eliminated the risk of future corrosion, removed the need for on-site preparation of steel plates and avoided introducing significant additional weight to the tank structure due to the volume of repairs required.
