Tube Sheet Heat Exchanger Rebuilding and Protective Coating

Application: HEX-Heat Exchangers

Substrate: NAB Nickel Aluminum Bronze

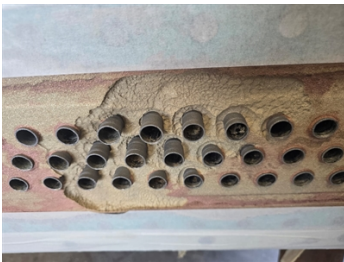
The customer manufactures and supplies heat exchanger units to end users under warranty. Units in service were experiencing premature failures caused by erosion and corrosion due to the high salt content of the water media, resulting in pitting, wall loss, and leaks at the tube sheet and water box. These failures were occurring within the warranty period, creating significant financial liability and reputational risk for the manufacturer.

Metal loss observed on the heat exchanger tube sheet.

1. The unit was cleaned and the surface prepared by abrasive blasting to achieve SSPC-SP10 / ISO 8501-1 Sa 2.5 cleanliness, removing all corrosion products and achieving the required anchor profile.
2. The pitted areas, wall loss zones, and tube sheet face were rebuilt to the original profile using Belzona 1111 (Super Metal), applied by Belzona spatula.
3. Belzona 1111 (Super Metal) was allowed to cure fully before overcoating.

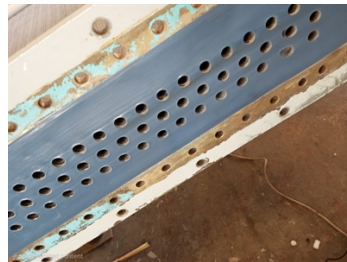
The tube sheet was rebuilt using Belzona 1111 (Super Metal) and coated with Belzona 1321 (Ceramic S-Metal).

4. Two full coats of Belzona 1321 (Ceramic S-Metal) were applied by brush and roller to the tube sheet face, water box interior and cover.

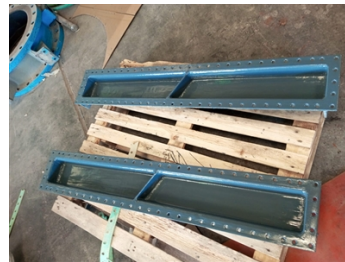
The covers were rebuilt using Belzona 1111 (Super Metal) and coated with Belzona 1321 (Ceramic S-Metal).
