Condenser Tube Sheet Repair and Protection in a Power Plant

ID: 10274

Industry: Power
Application: HEX-Heat Exchangers
Substrate: Carbon steel
Products: Belzona 1111 (Super Metal), Belzona 1321 (Ceramic S-Metal)

Customer Location: Jeddah
Application Date: May 2026

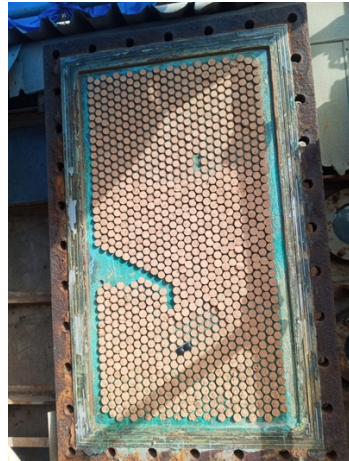
A major power plant was experiencing severe corrosion damage to condenser tube sheets, resulting in deterioration of the tube sheets and associated tubes. The mechanical contractor initially recommended complete replacement of the tube sheets and related tubing. However, this raised significant concerns for the plant authorities due to the high replacement cost, extended shutdown duration, and potential impact on power generation operations.

Initial condition of the heat exchanger tube sheets.

Hatcon proposed an alternative solution to rebuild and protect the existing tube sheets using the proven combination of Belzona 1111 (Super Metal) and Belzona 1321 (Ceramic S-Metal). This approach eliminated the need for replacement while providing long-term corrosion and erosion protection.

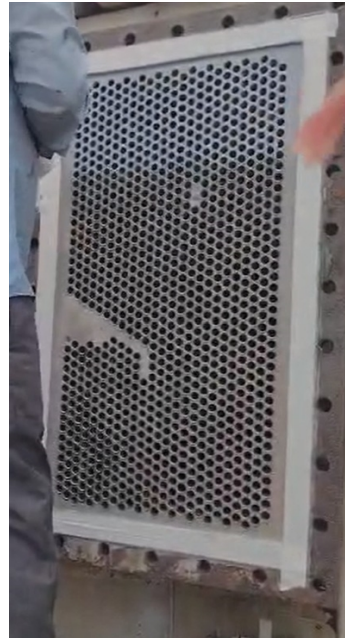
Cork plugs installed prior to abrasive blasting to protect the tubes during surface preparation.

1. Grit blasting of the internal surfaces was carried out using angular abrasives to achieve the required SSPC-SP10 / ISO 8501-1 Sa 2.5 cleanliness and a minimum surface profile of 3 mils (75 microns). The blast profile was verified by conducting test patches using Testex Press-O-Film Replica Tape and a micrometer, while chloride ion contamination testing was performed using Elcometer 134S test kits.

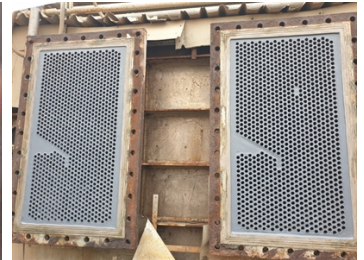
Tube sheets after abrasive blasting to SSPC-SP10 / ISO 8501-1 Sa 2.5 cleanliness standards.

2. Belzona 1111 (Super Metal) was mixed and applied using Belzona applicators to areas affected by pitting and metal loss.
3. Belzona 1111 (Super Metal) was allowed to cure in accordance with the Belzona Instructions for Use (IFU), followed by sweep blasting of the repaired surfaces prior to coating application.

4. Belzona 1321 (Ceramic S-Metal) was mixed and applied to the entire prepared surface using a stiff bristled brush in two coats at the recommended dry film thickness (DFT).
