Internal coating of Ejector After Condenser Vessel

ID: 10276

Industry: Oil & Gas
Application: TCC-Tanks and Chemical Containment Areas
Substrate: Carbon steel
Products: Belzona 1511 (Super HT-Metal), Belzona 1593

Customer Location: South Africa
Application Date: April 2026

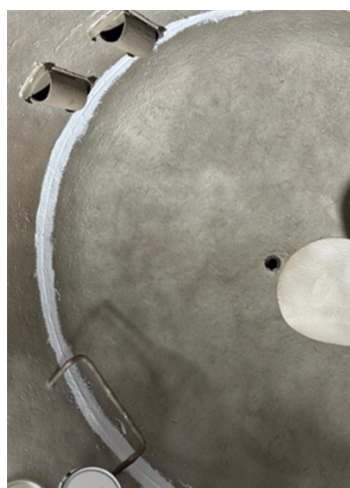
Rebuilding vessel weld seams with Belzona 1511

Due to signs of corrosion and pitting found on the internal surface of this high risk vessel, the client approached the distributor for advice on the protection of the vessel from further erosion/corrosion. Upon information received from the client, the following Belzona products were recommended. For rebuilding, Belzona 1511 (HT paste grade) and for corrosion/erosion Belzona protection Belzona 1593 was recommended. The application team completed the work in 4 days following the IFU specification. This directly contributed to extending the vessel's life expectancy.

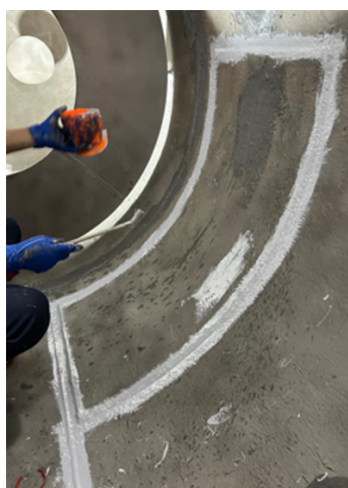
Rebuilding weld seams with Belzona 1511

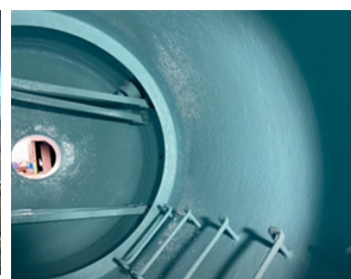
Internal coating of vessel with Belzona 1593

Belzona 1511 and 1593 was hand applied to IFU specification.
