Belzona 7311 Restores Thickness to Storage Tank

ID: 10277

Industry: Chemical & Petrochemical
Application: TCC-Tanks and Chemical Containment Areas
Substrate: Carbon steel
Products: Belzona 1161 (Super UW-Metal), Belzona 7311

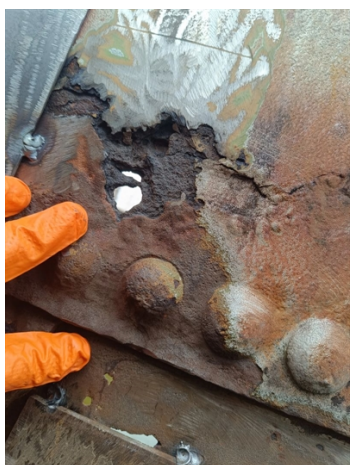
Damage to the tank

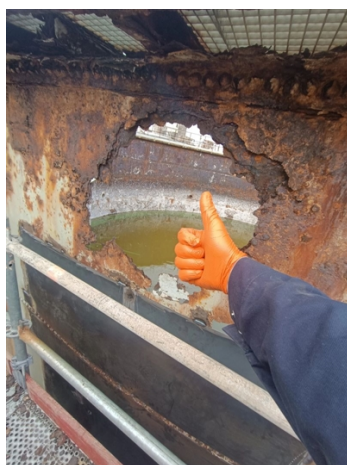
Severe corrosion on a brine storage tank was causing critical loss to the thickness. These tanks operate at a temperature range of 5°C to 40°C, and the customer required a cold bonding solution restore the holes and thickness in the tank. As you can see from the photographs the damage was quite serious in certain areas of the tank.

Further larger damage to the tank

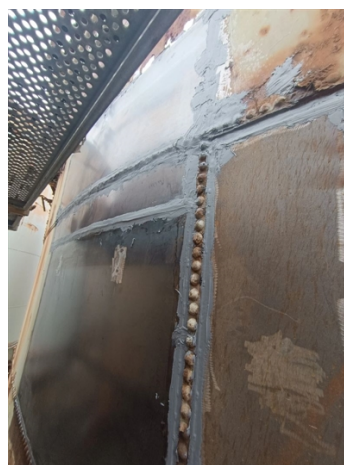
Belzona 1161 applied to thinner wall damaged areas

Initial surface preparation was first carried out using a wire brushing due to sandblasting and grinding being prohibited. First, 4mm thick plates were cold bonded using Belzona 1161. On the thinner walls, Belzona 7311 was used to bond 2mm thick plates, this was because the thinner walls were much more susceptible to twisting and flexing.

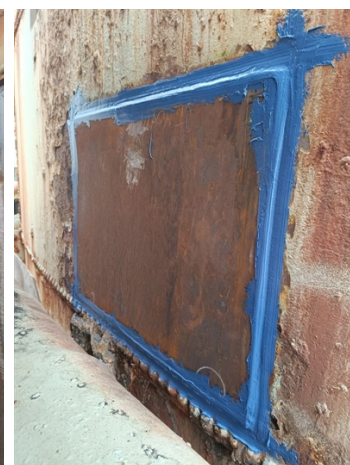
Belzona 7311 used to bond thicker plates
