Tank base sealing on Hot and Cold sump Vessels

ID: 10278

Application: GSS-Gaskets, Seals and Shims

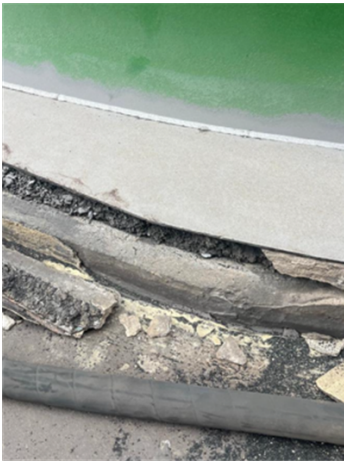
Worn and corroded bases on two storage tank vessels (Hot and Cold sumps) demanded attention to prevent structural failure or leaks. The Distributor was contacted by the Smelter Mine to inspect the vessels and provide a suitable and cost effective solution. The application approach using this two product system provides exceptional preventative and structural benefits.

On inspection

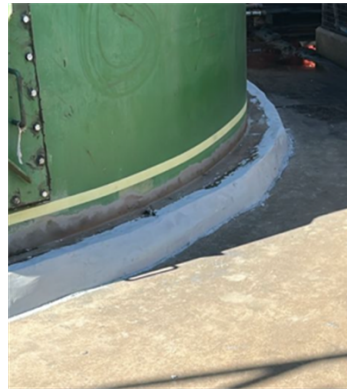
Rebuilding the concrete with Belzona 4111 Magma-Quartz

Belzona 4111 (Magma-Quartz) was used to rebuild the concrete structure. With Belzona 3111 (Flexible Membrane) breathable, microporous system applied to seal between the steel tank and concrete.

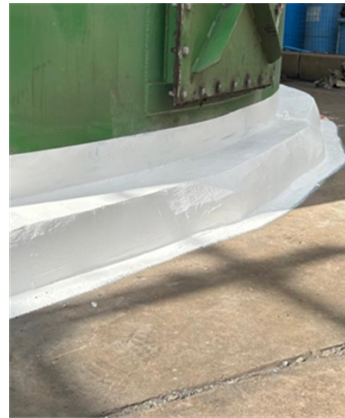
After applying Belzona 3111 Flexible Membrane

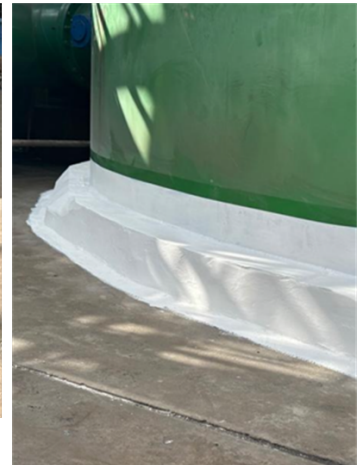
After applying Belzona 3111 Flexible Membrane to vessel base
