# Protecting Papermill Volute Pump Casings from Severe Abrasion with Belzona

ID: 10283

Application: CEP-Centrifugal Pumps

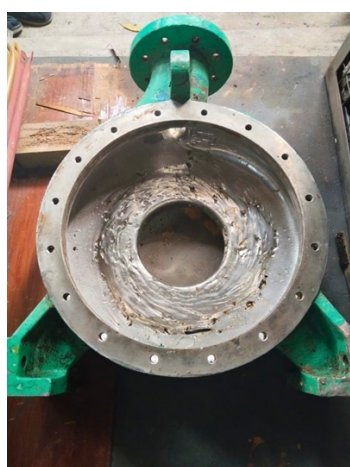
The volute pump casing used in the papermill operation suffered severe abrasive wear and leakage due to continuous exposure to abrasive slurry during operation. Progressive erosion of the internal surfaces resulted in material loss, reduced pump efficiency, and increased risk of equipment failure. The worsening condition eventually required shutdown of operations for immediate repair and restoration to prevent further operational losses and unplanned downtime.

Severe abrasive wear and leakage

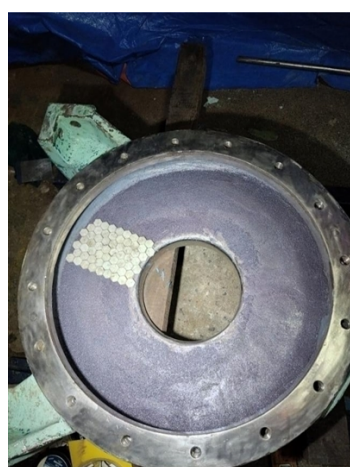
Belzona 1161 (Super UW-Metal) rebuild completed prior to installation of Belzona 9811 Alumina Tiles

The damaged volute pump casing was initially cleaned and mechanically prepared to remove contaminants, corrosion products, and deteriorated material. Surface preparation was carried out using grinding and abrasive blasting to achieve a clean and roughened profile suitable for bonding. Belzona 1161 (Super UW-Metal) was then applied to rebuild and restore the worn metal surfaces. After rebuilding, Belzona 1812 (Ceramic Carbide FP) was used as the adhesive and grout material for the installation of Belzona 9811 Alumina Tiles. The alumina tiles were carefully installed with no gaps to ensure maximum abrasion resistance and proper alignment along the internal contours of the volute pump casing. Final inspection was conducted to verify complete coverage and proper tile bonding prior to returning the equipment to service.

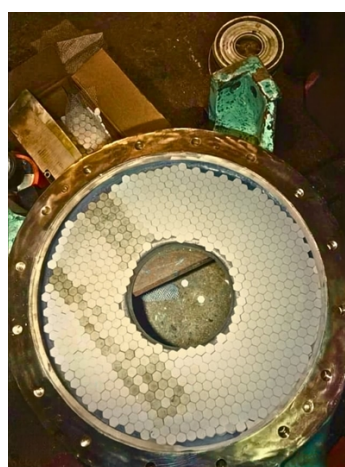
Installation of Belzona 9811 Alumina Tiles completed

Belzona 1161 (Super UW-Metal) was used to rebuild the damaged metal areas, while Belzona 1812 (Ceramic Carbide FP) was used as the adhesive and grout for the installation of Belzona 9811 Alumina Tiles to provide long-term protection against severe abrasion.

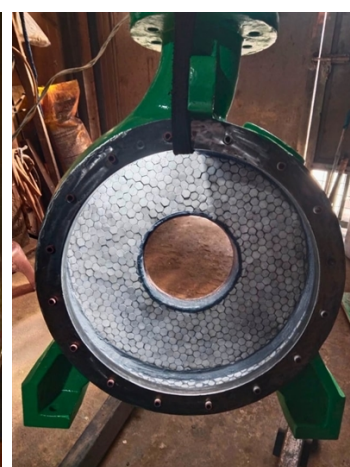
Completed installation and grouting of Belzona 9811 Alumina Tiles
