Belzona created anti-slip protection for internal cement transport area

ID: 10284

Industry: Cement

Application: FPA-Floor Problem Areas

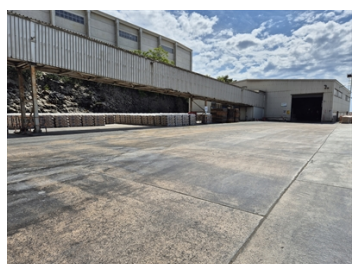
Forklifts transporting cement pallets between the palletizing hall and the loading and storage platform were slipping on the smooth concrete surface, particularly during turning manoeuvres. Customer wanted a durable solution, which could withstand the load. Roughness should be sufficient to prevent slipping, without damaging tires of forklifts and trucks.

Initial condition

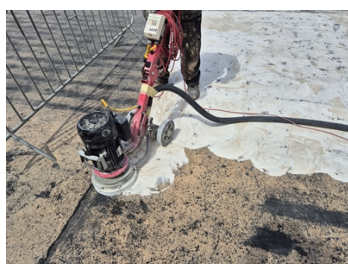
Surface preparation in progress

The application was carried out in accordance with Belzona Know-How System Leaflet FPA-8. The concrete substrate was washed with high-pressure water, mechanically prepared using a diamond grinding head to remove dirt, grease and remnants of the previous coating, and then washed again to remove dust. Belzona 5231 was roller-applied at 400 microns and Belzona 9221 (Surefoot Aggregate White) was then incorporated to produce the required anti-slip profile. To minimise the risk of outgassing, the material was applied in the evening.

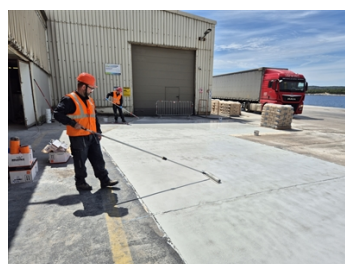
Application of Belzona 5231 and Belzona 9221 in progress
