# Nitric Acid Storage Tank Stair Support Repair

ID: 10286

**Industry:** Chemical & Petrochemical  
**Application:** TCC-Tanks and Chemical Containment Areas  
**Substrate:** Stainless-steel  
**Products:** Belzona 5721, Belzona 7311

**Customer Location:** Geismar  
**Application Date:** June 2026

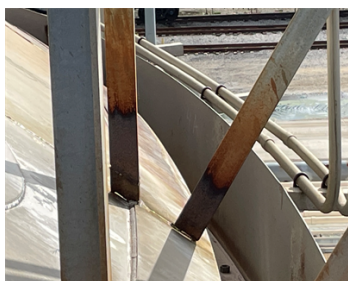
During inspection of the N4 Nitric Acid Storage Tank, Customer discovered that several welds attaching the roof access stair support brackets to the tank roof had separated. These brackets are critical for supporting the stairway used to access the top of the tank for inspection and maintenance activities.

Failed welds on the stair support brackets had separated from the tank roof, creating a structural concern and requiring an engineered repair solution without the use of hot work.

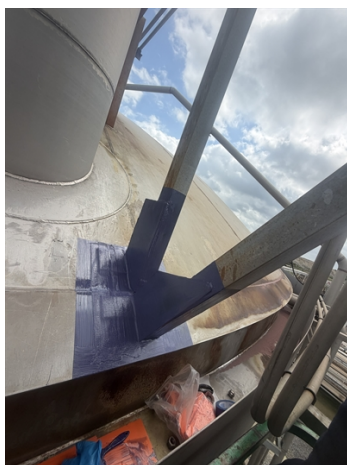
Two layers of Belzona 9341 reinforcement fabric were embedded into Belzona 7311 over the bonded plates, creating a high-strength composite system that restored the structural connection.

then used to rebuild the failed weld areas and bond custom-fabricated steel plates between the tank roof and stair supports. Once the plates were secured, two layers of Belzona 9341 reinforcement fabric were installed and saturated with Belzona 7311 to create a high-strength composite repair. After curing, the repair was coated with Belzona 5721 to protect against UV exposure and weathering.

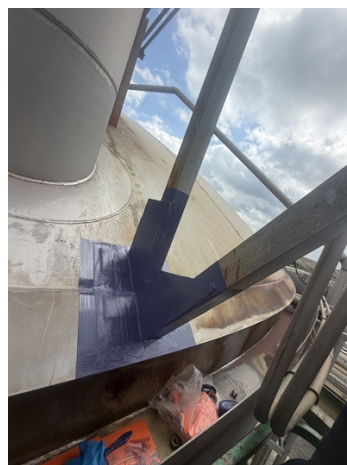
Two layers of Belzona 9341 reinforcement fabric were embedded into Belzona 7311 over the bonded plates, creating a high-strength composite system that restored the structural connection.

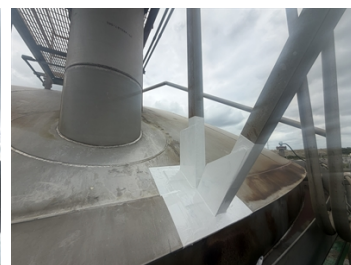
The completed repair was finished with a protective coat of Belzona 5721, providing long-term UV and weather resistance while restoring the stair support system without hot work.
