BELZONA PROTECTION OF CO₂ COMPRESSOR

ID: 1029

Customer Location: Soda plant, Bulgaria

100,000 m³/h multistage centrifugal compressor of CO₂

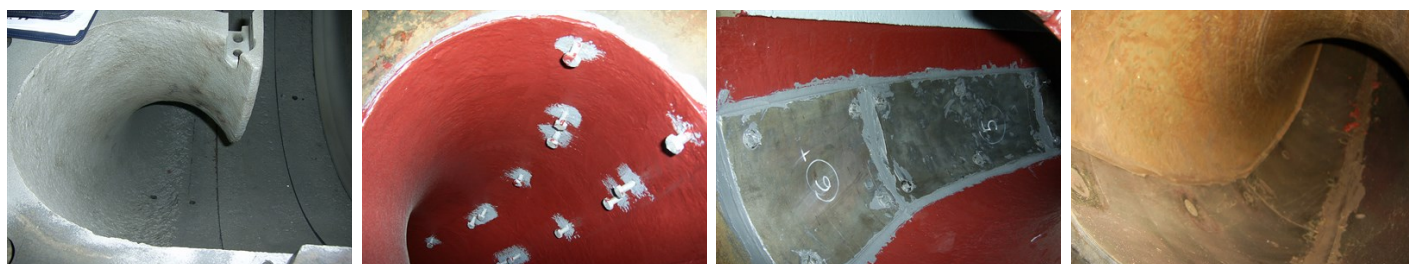
Photograph Descriptions

Erosion/corrosion damages on the outlet section due to high temperatures (110°C), water injection and acid contaminated flue gas.

* Erosion/corrosion damage to the internal surfaces reviewed after blasting Belzona® 1392 applied Belzona® 1311 used to fix the stainless steel plates View of the protected internal profile after 2,000 working hours in service of application made in 2005 ,

No other effective alternative available. Stainless steel cladding was fit on the most damaged sections using Belzona® 1311 to provide further protection. Inspection after 6 months and 2,000 working hours of the unit reviewed only slight discolouration and loss of gloss. According to this application method five compressors have been protected in the plant.
