BELZONA KEEPS CUSTOMERS ROLLING

ID: 1033

Industry: *General Industry*
Application: *SHM-Solids Handling Machinery*

Tire repair

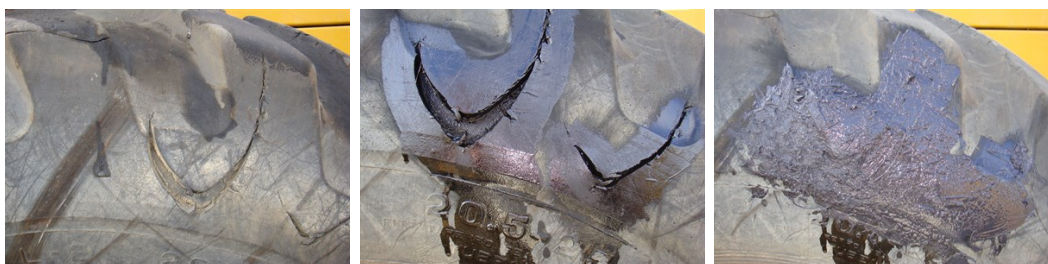
Photograph Descriptions

After the rental was returned they saw the damage and needed a repair right away, knowing the unit was booked to go right back out.

- * Damage to the tire ,
- * After the roughing surface conditioned ,
- * Belzona® 2311 completed repair ,

Application was carried out using a modified Belzona Know-How System Leaflet SHM-1. The Surface was roughed with roughing brush, Conditioned then gouges in tire repaired with the Belzona® 2311.
