# BELZONA HELPS TO STOP LEAKAGE

Industry: Power  
Application: VPF-Valves, Pipes and Fittings  
Substrate: Steel  
Products: \* Belzona® 1221(Super E Metal) ,  
\* Belzona® 1291 (ES-Metal) ,

Customer Location: Power plant, Bulgaria  
Application Date: June 2003

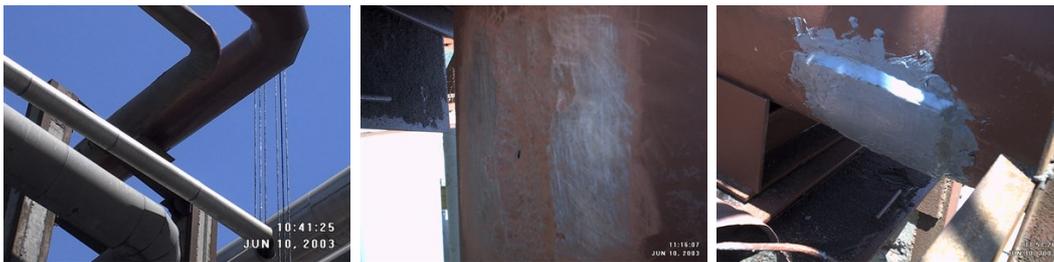
## Photograph Descriptions

Leakage from the pipe caused by erosion/corrosion.

- \* General view of the pipe to be repaired at high level more than 10 m above the ground ,
- \* The hole revealed and surrounding area roughened ,
- \* Reinforcement patch applied with Belzona® 1221 pressed over the leak ,

Application was carried out in accordance with Belzona Know-How System Leaflet VPF-11a.

The leakage from the pipe had to be stopped by the fastest possible way. In the situation conventional repair by welding was not possible. The hole was sealed with Belzona in only a couple of hours.
