BELZONA REPAIR OF CONVEYOR BELT

ID: 1037

Industry: *Power*
Application: *SHM-Solids Handling Machinery*

Customer Location: *Power plant, Bulgaria*
Application Date: *August, 2002*

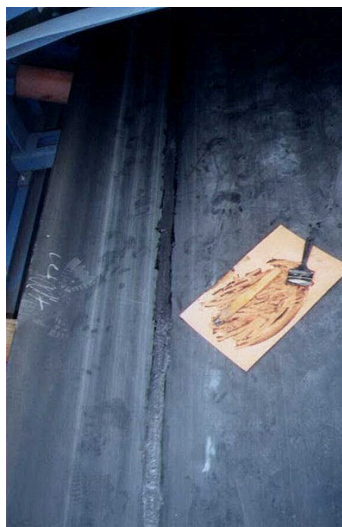
Mechanical damage on the protector/scrapper was exposing the metal reinforcement

* View of the conveyor belt facility , * Conditioning with Belzona® 2911 , * Belzona® 2311 used to rebuild the damage ,

5 km conveyor belt for transporting coal to the power plant

The application was carried out in accordance with Belzona Know-How System Leaflet SHM-1.

The customer required the repair with minimum down-time. Belzona was chosen for its effective simple and fast accomplishment without special equipment as per alternative hot vulcanization method.
