# BELZONA SEALS CEILING IN CHICKEN PLANT

ID: 1038

Ceiling joints at the Chicken plant

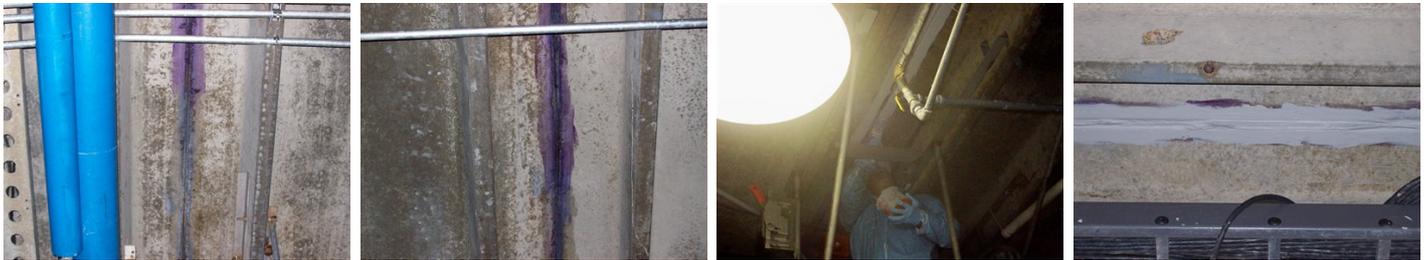
*Carbon steel metal that is between the concrete prefabricated roof is rusting. The rust is falling onto the chickens and workers as they are being processed. The FDA came in and made them do a repair for the problem.*

- \* View of the joint with metal and concrete ,
- \* Application of Belzona 3911 ,
- \* Applying Belzona 3111 ,
- \* Completed application ,

The application was carried out in accordance with Belzona Know-How System Leaflet RPA-1.

The work have to be done on the weekends. The only alternative was to use an epoxy concrete material to seal the joints and stop the rust from falling. Using the Belzona materials, we saved the plant \$50,000 and completed the project in four weekends, using 10 buckets of Belzona 3111.
