Belzona Saves Refinery Millions

Industry: Oil & Gas
Application: TCC-Tanks and Chemical Containment Areas
Substrate: Carbon Steel
Products: * Belzona® 1511 (Super HT-Metal) ,
* Belzona® 1591 (Ceramic XHT) ,

Customer Location: Oil Refinery - Tuscaloosa, AL USA
Application Date: February 2008

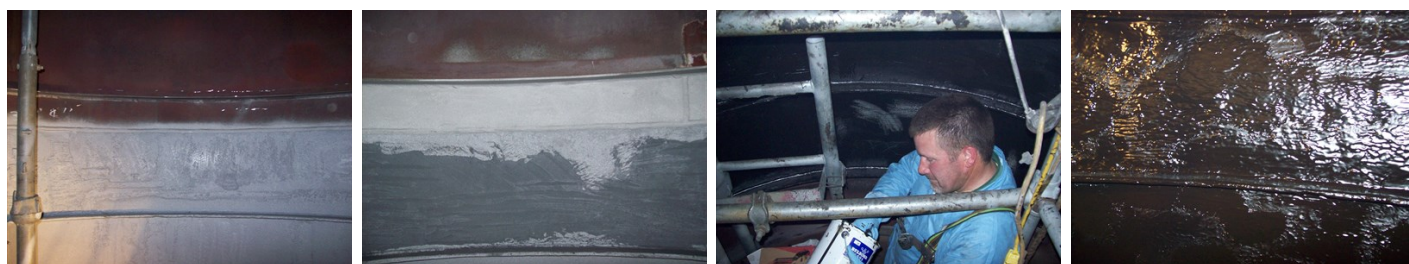
Photograph Descriptions

Corrosive process fluids and elevated temperatures create an extremely aggressive corrosion rate. If corrosion was not addressed, this vessel would have gone under its minimum wall thickness and forced a shutdown.

- * Abrasive blasted area ,
- * Repaired area with Belzona® 1511 ,
- * Application of Belzona® 1591 ,
- * Finished application after pinhole testing ,

Amine regeneration tower operating above 250°F in an environment containing hydrogen sulfide and diglycolamine.

Belzona® 1511 and Belzona® 1591 were applied in accordance with Belzona Know-How System Leaflet TCC-5.

Possible repairs included a Belzona solution or clad welding the affected area. The Belzona solution required less than \$40,000 of product and labor and was completed in three days. The clad welding would have required \$100,000 of product and labor and more importantly 10 days. Because daily lost production costs were \$9,000,000, the Belzona solution saved the refinery over \$63,000,000!
