BELZONA® 4811 REPAIRS TO CONTIMIX HYDROPULPER IN PAPER MILL

ID: 104

Application: *SHM-Solids Handling Machinery*

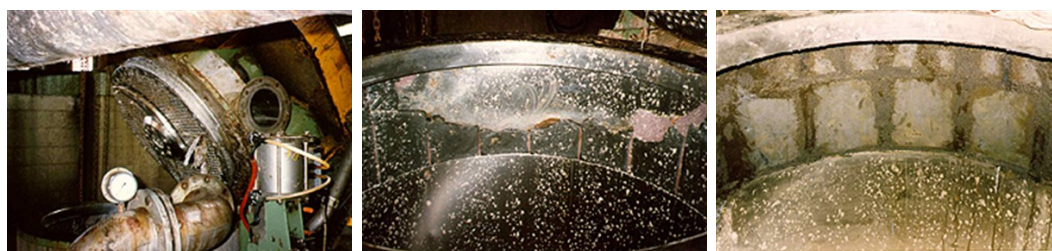
Photograph Descriptions

Basalt tile lining damaged and efficiency of machine impaired.

- * View of equipment with lid raised showing the pulping blade ,
- * The area of damaged tiles ,
- * Tiles re-bonded and grouted with Belzona® 4811 ,

Basalt tiles are individually made to size and shape and were not readily available. Repairs with Belzona ensured production was not unduly interrupted. Belzona® 4811 ensured in-fill areas were capable of withstanding the high abrasion similar to the basalt.
