BELZONA CLEARS CLARIFIER PROBLEM

ID: 1045

Customer Location: Waste Water Utility, Oklahoma
Application Date: March, 2007

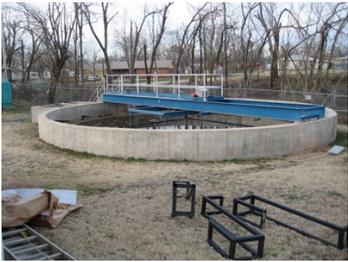
Clarifier

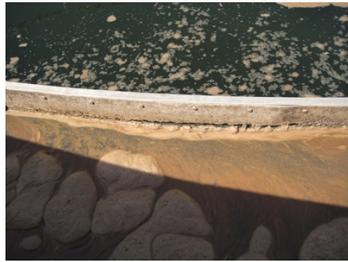
50% of the shield had been eroded away due to corrosion at the water line. A new skirt from the manufacturer would cost over \$15,000 and take unduly long to install.

Eroded Aluminum

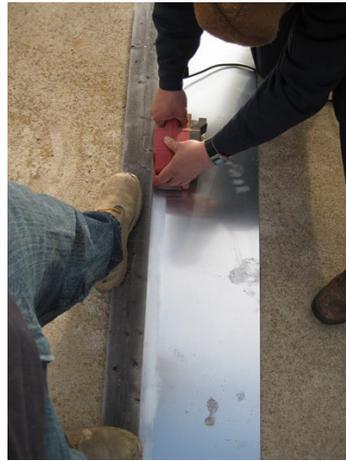
Preparing the panels

Abraded new aluminum panels and coated with Belzona® 3921 and Belzona® 5811 in accordance with Belzona Know-How System Leaflet TCC-5. The panels were then bolted to the sound skirt eliminating need for complete replacement.

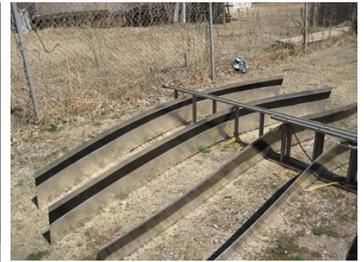
Finished panels coated at the waterline on both sides
