BELZONA CLEARS CLARIFIER PROBLEM

Industry: Water / Wastewater

Application: TCC-Tanks and Chemical Containment Areas

Customer Location: Waste Water Utility, Oklahoma

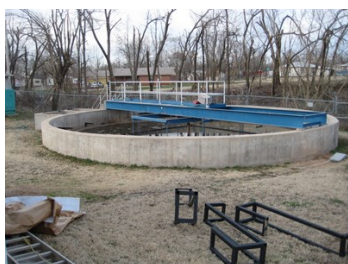
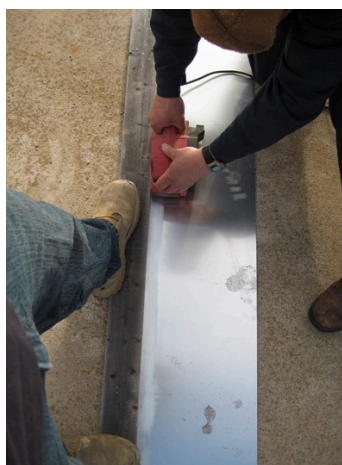
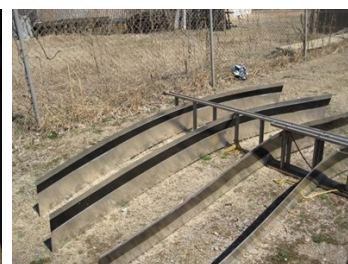
Photograph Descriptions

50% of the shield had been eroded away due to corrosion at the water line. A new skirt from the manufacturer would cost over \$15,000 and take unduly long to install.

* ClarifierEroded AluminumPreparing the panelsFinished panels coated at the waterline on both sides ,

Abraded new aluminum panels and coated with Belzona® 3921 and Belzona® 5811 in accordance with Belzona Know-How System Leaflet TCC-5. The panels were then bolted to the sound skirt eliminating need for complete replacement.
