# BELZONA CLEARS CLARIFIER PROBLEM

ID: 1045

Industry: Water / Wastewater

Customer Location: Waste Water Utility, Oklahoma

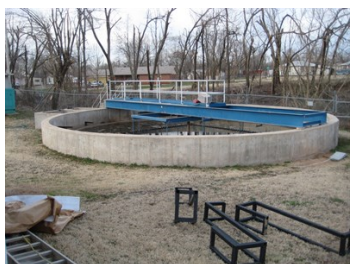
Clarifier

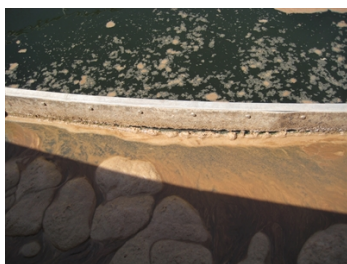
50% of the shield had been eroded away due to corrosion at the water line. A new skirt from the manufacturer would cost over \$15,000 and take unduly long to install.

Eroded Aluminum

Abraded new aluminum panels and coated with Belzona® 3921 and Belzona® 5811 in accordance with Belzona Know-How System Leaflet TCC-5. The panels were then bolted to the sound skirt eliminating need for complete replacement.

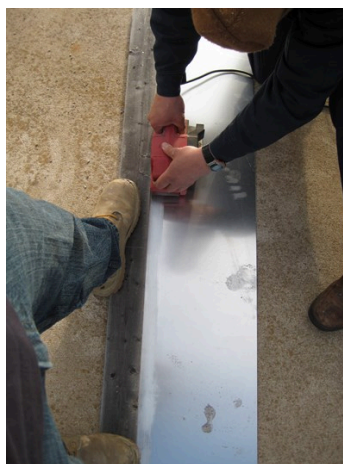
Preparing the panels

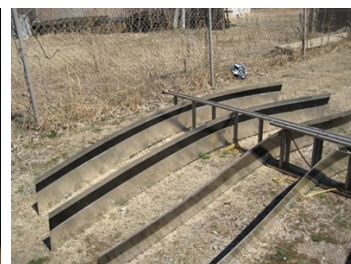
Finished panels coated at the waterline on both sides
