# BELZONA REBUILDS LIFT PUMP

ID: 1047

Customer Location: Waste Water Utility, Oklahoma  
Application Date: September 2006

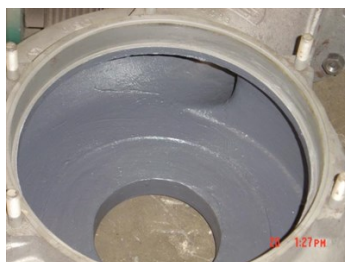
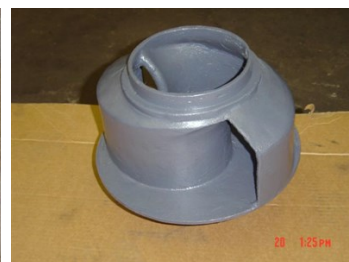
*Pump had lost efficiency and had to be pulled. The model was foreign and had a four week lead time for parts.*

- \* Eroded impeller ,
- \* Impeller reinforced and blasted ,
- \* Blasted and coated bowl ,
- \* Impeller after balance and rebuild ,

Application was carried out in accordance with Belzona Know-How System Leaflets CEP-1, CEP-3 and CEP-5.

This impeller and bowl was rebuilt in a local repair shop using Belzona for 40% of the cost of a new one. The customer reported that when reinstalled the check valve has never gone higher!
