BELZONA REBUILDS LIFT PUMP

ID: 1047

Customer Location: Waste Water Utility, Oklahoma
Application Date: September 2006

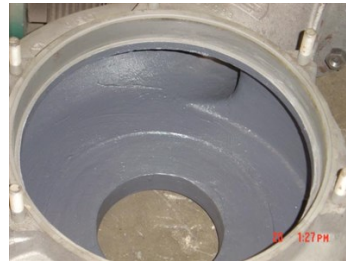
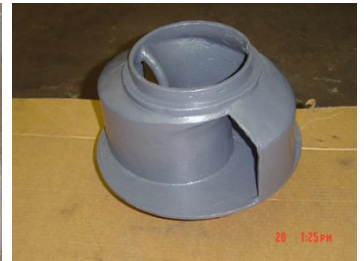
Pump had lost efficiency and had to be pulled. The model was foreign and had a four week lead time for parts.

- * Eroded impeller ,
- * Impeller reinforced and blasted ,
- * Blasted and coated bowl ,
- * Impeller after balance and rebuild ,

Application was carried out in accordance with Belzona Know-How System Leaflets CEP-1, CEP-3 and CEP-5.

This impeller and bowl was rebuilt in a local repair shop using Belzona for 40% of the cost of a new one. The customer reported that when reinstalled the check valve has never gone higher!
