# BELZONA REPAIRS HEAVY DUTY SHAFT

ID: 1048

Industry: *Mining & Quarrying*  
Application: *MPT-Mechanical Power Transmission*

Customer Location: *Rock Quarry & Cement Plant*  
Application Date: *April, 2006*

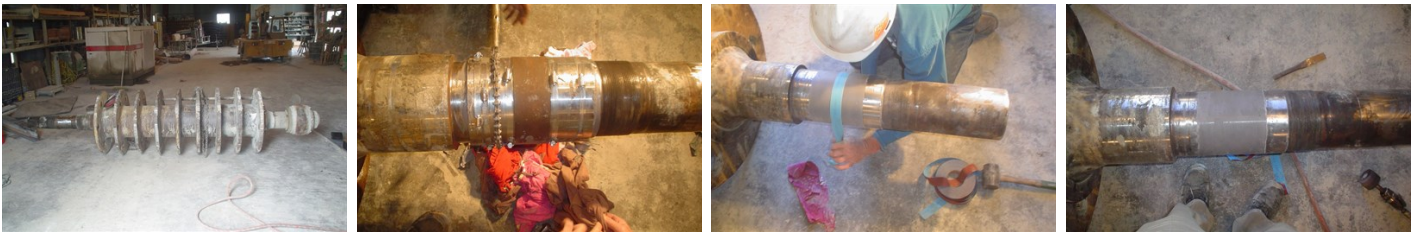
## Photograph Descriptions

*A bearing spun on the rock crusher at the cement plants quarry. Without the crusher back in service the entire quarry and cement plant would shut down.*

\* Rock crusher Belzona® 1111 in split mold Sanding shaft to size Shaft ready to go to work ,

Obsolete rock crusher from the 1950s. It has 300lb hammers on it. Used in the cement plants own quarry.

Application was carried out in accordance with Belzona Know-How System leaflet MPT-2.

This application had untold savings from downtime as plant was unsure what to do with no immediate alternative. The reliability engineer has been monitoring this for 2 years and the repair is holding up well day to day.
