BELZONA FLOOR IS UP FOR HOT BATH

ID: 1049

Industry: *Buildings & Structures*
Application: *FPA-Floor Problem Areas*
Substrate: *Brick & Mortar*
Products: *Belzona® 4181 (AHR Magma Quartz)* <div>*Belzona® 5891 (HT Immersion Grade)* </div>

Customer Location: *Dairy, Oklahoma*
Application Date: *March, 2008*

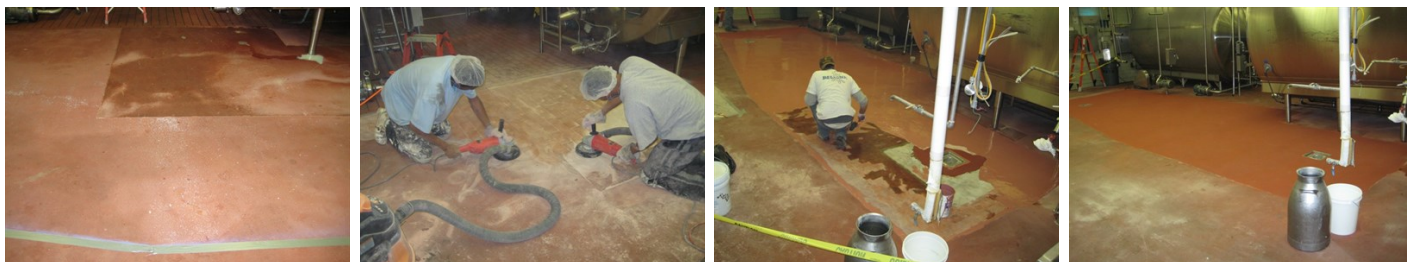
Photograph Descriptions

Existing floor covering badly deteriorated due to regular spills of hot CIP solutions. The dairy is only down from production on Saturday/Sunday.

* Old floor , * Surface preparation , * Coating the floor , * The rebuilt and finished floor ,

Application was carried out in accordance with Belzona Know-How System Leaflets FPA-1 & -8. The existing coating was removed with diamond grinders and dust collectors. The floor was repaired with Belzona® 4181, then Belzona® 5891 was applied over the top with a non-slip aggregate on the surface.
