# OVERNIGHT FLOOR REPAIRS COMPLETED WITH BELZONA

ID: 1051

Industry: Buildings & Structures  
Application: FPA-Floor Problem Areas  
Substrate: Concrete  
Products: Belzona® 4111 (Magma Quartz)

Customer Location: Dairy, Oklahoma U.S.A.  
Application Date: October, 2007

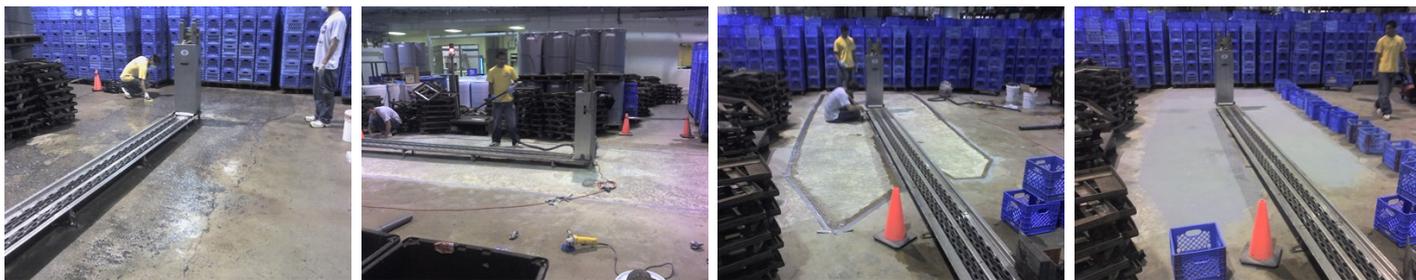
Floor was eroded and very slippery causing a safety hazard and slowing workers down. There is only an 8 hour window for this repair.

\* Dirty floor , \* Surface preparation , \* Applying tape & Belzona® 4911 Conditioner , \* Squeegee coat of Belzona® 4111 slurry & non-slip applied ,

After cleaning and grinding floor, pre-warmed Belzona® 4111 mixed as a slurry was applied with a squeegee and surface loaded to rejection with Belzona non-slip aggregate.
