# BELZONA KEEPS VEHICLES MOVING

Customer Location: Vehicle Testing Station Bratislava,  
Slovakia

Application: FPA-Floor Problem Areas

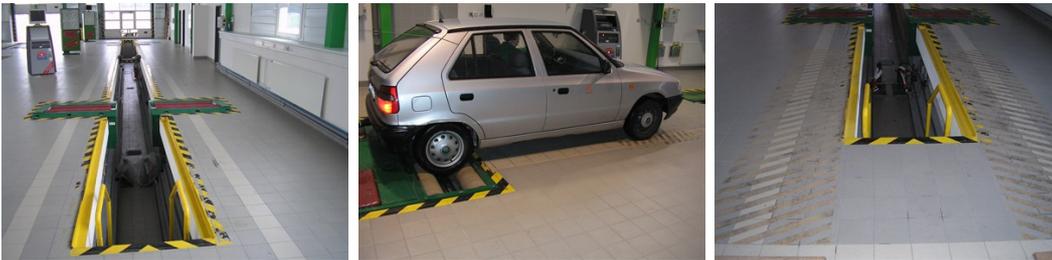
During the rain or snow, vehicles were slipping when moving off the brake testing rollers.

- \* 1. Vehicle Testing Station ,
- \* 2. Vehicle during the brake testing ,
- \* 3. 2 years in service ,
- \* ,

The application was carried out in accordance with Belzona Know-How System Leaflet FPA-8. Belzona 5811 was applied by brush in a diagonal stripe pattern and blinded with Belzona® 9211.
