BELZONA PROTECTS TUBE SHEET AND TUBES

ID: 1056

Application: HEX-Heat Exchangers

Customer Location: Steel mill, Slovakia

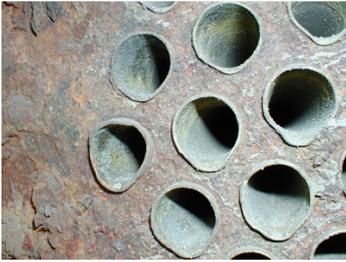
Corrosion problems were beginning on the tube sheet and inlet tubes (75 mm).

Damaged exchanger tube.

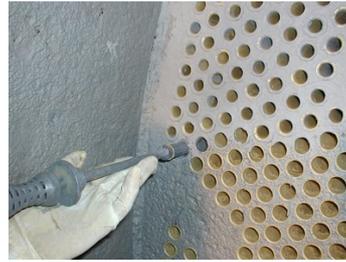
The protection of the inner surface of the pipes was done by gluing steel inserts inside the pipes.

Condenser tube sheets and tubes. The protection of the inner surface of the pipes was done by gluing steel inserts inside the pipes.

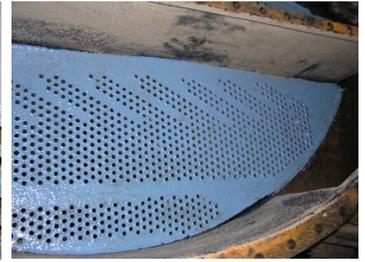
Top layer of Belzona 1341 product.

Belzona provided long term protection, increasing the life of the tube sheet and also inlet tubes, decreasing other repair and maintenance costs. Inspection after three years showed excellent protection being maintained.
