BELZONA PROTECTS TUBE SHEET AND TUBES

ID: 1056

Customer Location: Steel mill, Slovakia
Application Date: August 2003

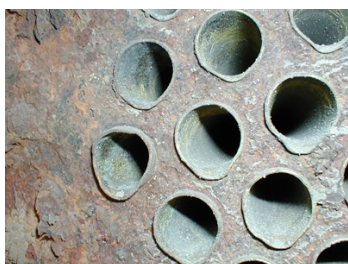
Corrosion problems were beginning on the tube sheet and inlet tubes (75 mm).

Damaged exchanger tube.

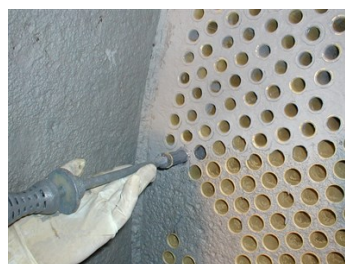
The protection of the inner surface of the pipes was done by gluing steel inserts inside the pipes.

Condenser tube sheets and tubes. The protection of the inner surface of the pipes was done by gluing steel inserts inside the pipes.

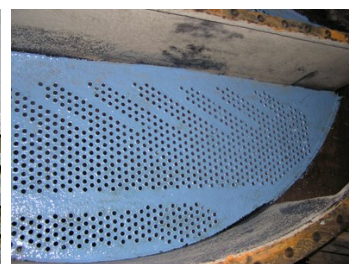
Top layer of Belzona 1341 product.

Belzona provided long term protection, increasing the life of the tube sheet and also inlet tubes, decreasing other repair and maintenance costs. Inspection after three years showed excellent protection being maintained.
