BELZONA REBUILDS SHAFT & KEYWAY ON JAW CRUSHER

ID: 1064

Industry: *General Industry*
Application: *MPT-Mechanical Power Transmission*

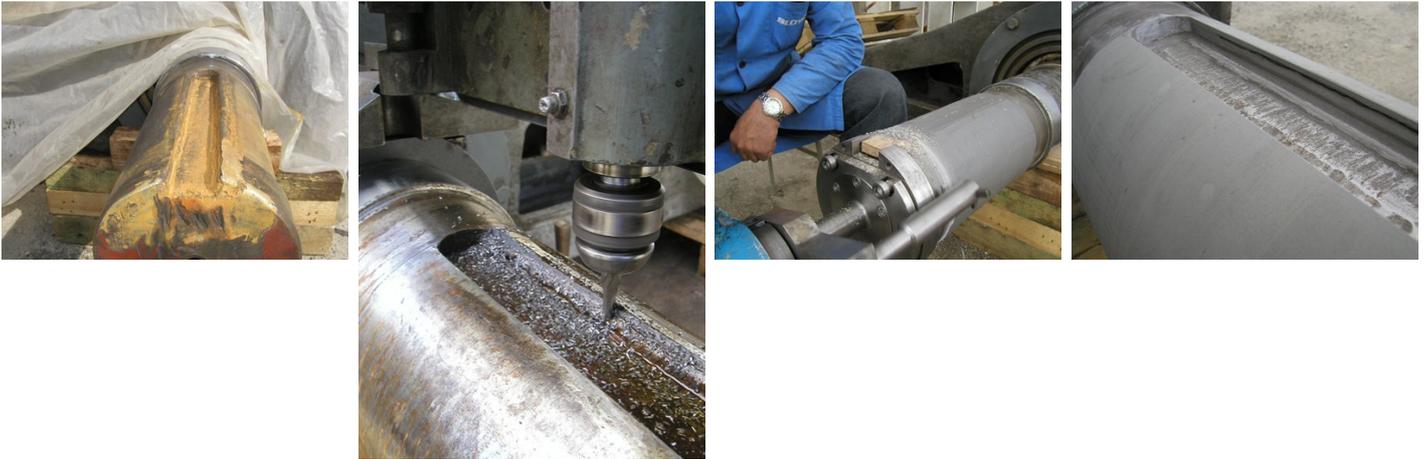
Shaft and keyway worn and damaged

* Damaged shaft , * Milling the keyway , * Turning the Belzona® 1111 rebuilt shaft , * Shaft ready to transport back to customer ,

Keyway was rebuilt by welding and milling operation. Belzona® 1111 was used for shaft repair. wooden former treated with release agent was used to form keyway. This repair saved customer a lot of time, because welding and drilling would have taken several weeks.
