# PROTECTION OF CARBIDE MIXTURE TRANSFER EQUIPMENT WITH BELZONA

ID: 1065

Customer Location: Calcium Carbide producer, Slovakia

Application: SHM-Solids Handling Machinery

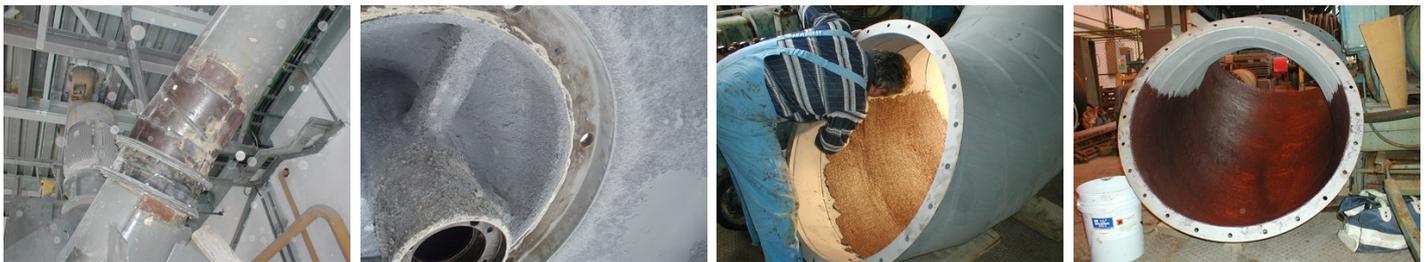
*The highly abrasive carbide mixture wears tubes, pipe bends as well as the crusher itself.*

- \* Repair of the pipes was constantly required ,
- \* The heavily damaged surface of the equipment ,
- \* The application of Belzona® 1811 to pipe bend ,
- \* The pipe bend ready for operation ,

Application was carried out in accordance with Belzona Know-How System Leaflet SHM-11.

Prior to the application it was required to change every 6 months the pipe sections as well as the parts of the crusher. Belzona application has prolonged the service life to 24 months, meaning that €24,000 was saved by customer over two years.
