BELZONA IMPROVES CONVEYER EFFICIENCY

ID: 1067

Application: *SHM-Solids Handling Machinery*

Customer Location: *Automotive company, Slovakia*

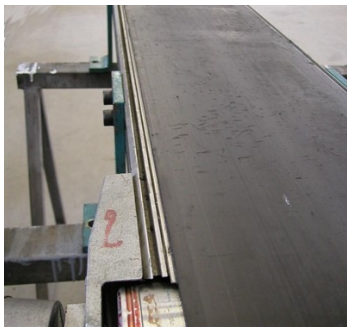
Products were sliding on the belt due to incline and smooth surface.

* Slippery belt , * Application of Belzona® 2211 , * Steel plates for moulding Elastomer to shape , * Completed belt ready to work ,
