# BELZONA IMPROVES CONVEYER EFFICIENCY

Application: *SHM-Solids Handling Machinery*

Customer Location: *Automotive company, Slovakia*

Products: *Belzona® 2211 (MP Hi-Build Elastomer)*

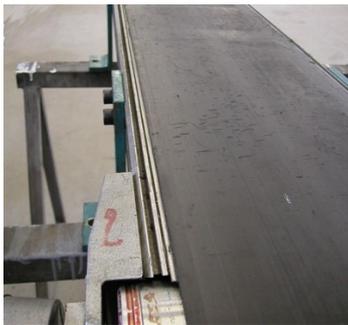
*Products were sliding on the belt due to incline and smooth surface.*

\* Slippery belt , \* Application of Belzona® 2211 , \* Steel plates for moulding Elastomer to shape , \* Completed belt ready to work ,
