BELZONA RESTORES SAFETY VALVE SEAL

ID: 1068

Customer Location: Power plant, Bulgaria
Application Date: June, 2005

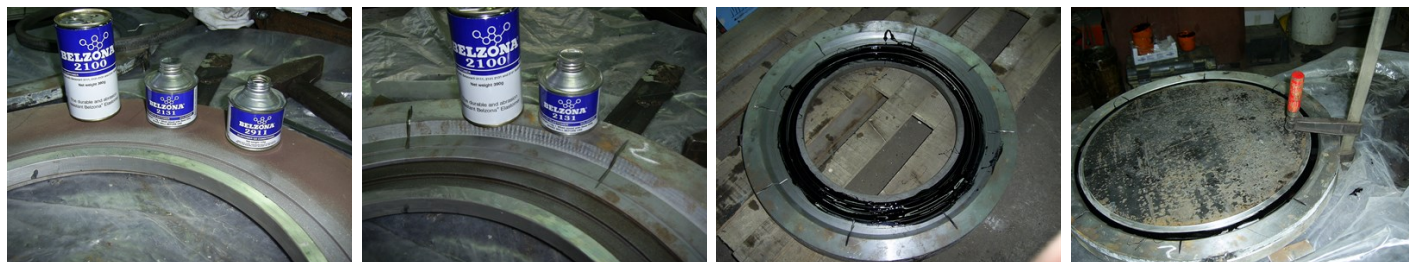
Photograph Descriptions

Damaged mating surface in the safety valve was allowing back-flow of water

* The safety valve plate , * The inner and outer forming rings put on the valve plate , * Belzona® 2131 poured in the gap between two forming rings , * The top forming plate clamped to form precise mating surface ,

Application was carried out in accordance with Belzona Know-How Leaflet GSS-1. Two forming rings(inner and outer to the valve diameter) were used to create the diameter profile and top plate used to form actual sealing face.

New valves were not available so the sealing surfaces were removed and Belzona® 2131 moulded to the original sealing profile. Belzona provided fast return to service. The alternative hot vulcanization required special equipment and extra time.
