# BELZONA REFURBISHMENT OF FLASH VESSELS USING INJECTION TECHNIQUES

ID: 107

Customer Location: *Nickel-Cobalt Refinery, Western Australia*

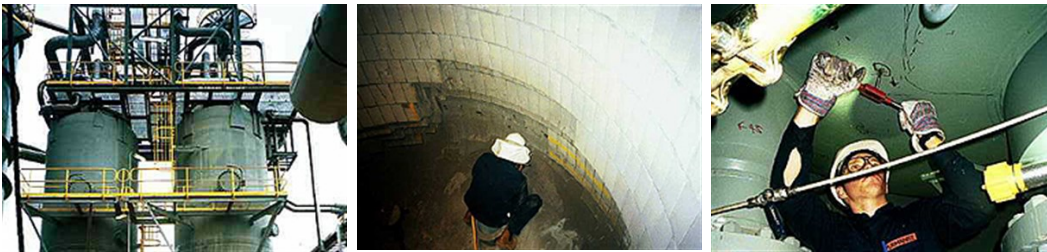
*Vessel has a titanium insert in domed base and is also refractory brick lined. A void 1-20mm beneath insert allowed it to crack at start-up.*

- \* General View of two flash vessels on Train 2 ,
- \* Work underway from inside ,
- \* Injection holes being drilled & tapped prior to injection from outside vessel ,

## Application Method

Application was carried out in accordance with Belzona System Leaflet GSS-9.
