BELZONA REFURBISHMENT OF FLASH VESSELS USING INJECTION TECHNIQUES

Customer Location: Nickel-Cobalt Refinery, Western Australia

Application: GSS-Gaskets, Seals and Shims

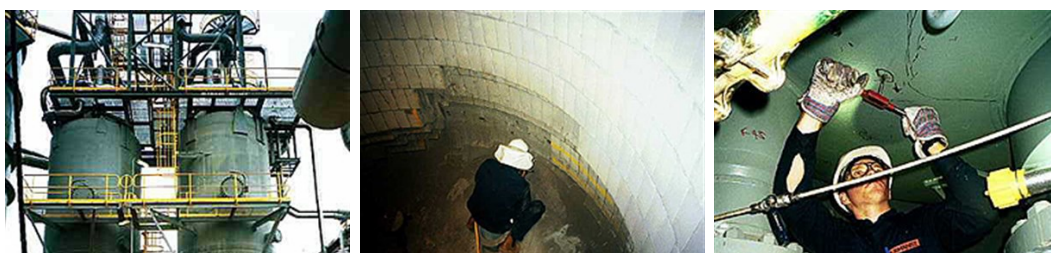
Photograph Descriptions

Vessel has a titanium insert in domed base and is also refractory brick lined. A void 1-20mm beneath insert allowed it to crack at start-up.

- * General View of two flash vessels on Train 2 ,
- * Work underway from inside ,
- * Injection holes being drilled & tapped prior to injection from outside vessel ,

Carbon steel flash vessels operating at 250°C and 20 bar pressure.

Application was carried out in accordance with Belzona System Leaflet GSS-9.
