# INJECTION OF BELZONA REPAIRS SHAFT

ID: 1070

Industry: Power  
Application: MPT-Mechanical Power Transmission

Customer Location: Hydropower Station, Spain  
Application Date: February 2008

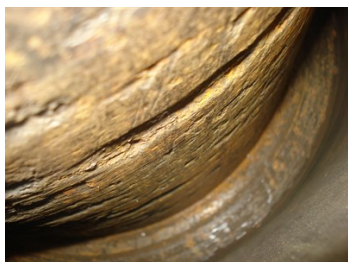
After more than 30 years working, the shaft had severe damage and loss of diameter causing water leaks

\* Original shaft damage , \* Heating the shaft with the former already installed , \* Injecting Belzona between the shaft and the former , \* Shaft rebuilt and protected at the same time ,

Replacement of the shaft would have needed a large part of the installation to be disassembled. With Belzona the customer saved these high costs and has restored shaft with improved corrosion resistance. Use of former enabled shaft to be accurately reformed in-situ.
