# INJECTION OF BELZONA REPAIRS SHAFT

ID: 1070

Customer Location: *Hydropower Station, Spain*  
Application Date: *February 2008*

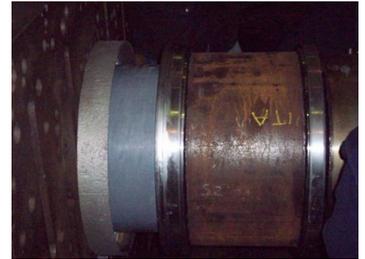
*After more than 30 years working, the shaft had severe damage and loss of diameter causing water leaks*

\* Original shaft damage , \* Heating the shaft with the former already installed , \* Injecting Belzona between the shaft and the former , \* Shaft rebuilt and protected at the same time ,

Replacement of the shaft would have needed a large part of the installation to be disassembled. With Belzona the customer saved these high costs and has restored shaft with improved corrosion resistance. Use of former enabled shaft to be accurately reformed in-situ.
